**SAS Superstructure**

**Daily Diary Report by Bid Item**

Contract No.: 04-0120F4

04-0120F4  
04-SF-80-13.2/13.9  
Self-Anchored  
Suspension Bridge

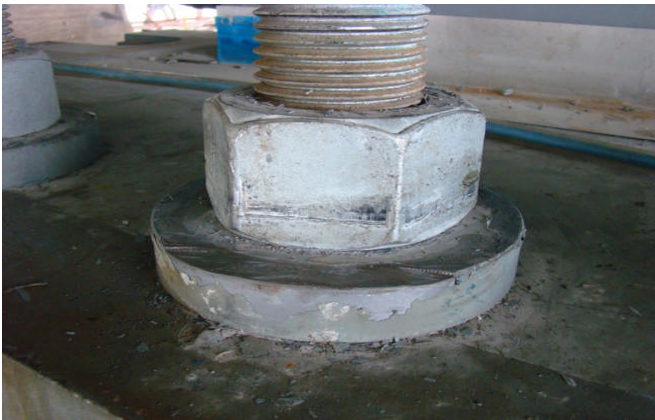
Another attempt on anchor rods B1B1 and B1C1 was attempted using the pump and jack from the bottom. Once again the effort to tighten and turn the nut on these two rods was unsuccessful. However using this pump/jack the recorded Pjack value was 15.0ksi on B1B1 and 17.0ksi for B1C1. ABF engineer Adam Reeve informed me that a beveled washer was being made to try and seat the jack properly. Hopefully this will allow the nut to be tightened/turned to lock the Pjack load of 19.5ksi in the rod. See photos below for the damage to the nut/washer as a result of eccentric/partial bearing between the washer and jack bridge.

Washer and nut of anchor rod B1C1 where the marks show how the gear box unevenly tightened the nut after retensioning the rod.

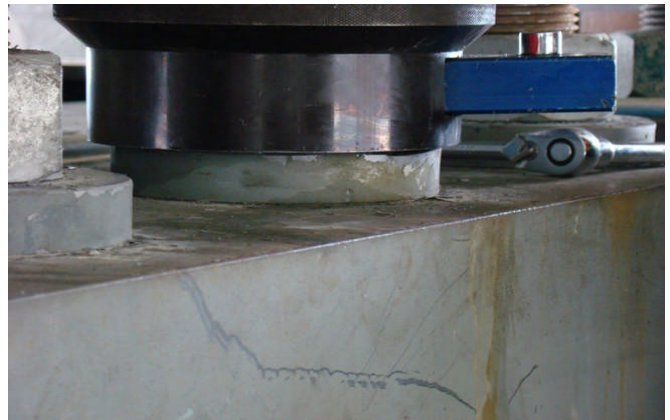
Jack bridge not in full contact with the washer for anchor rod B1C1 preventing turning the nut at the Pjack pressure of 19.5ksi.

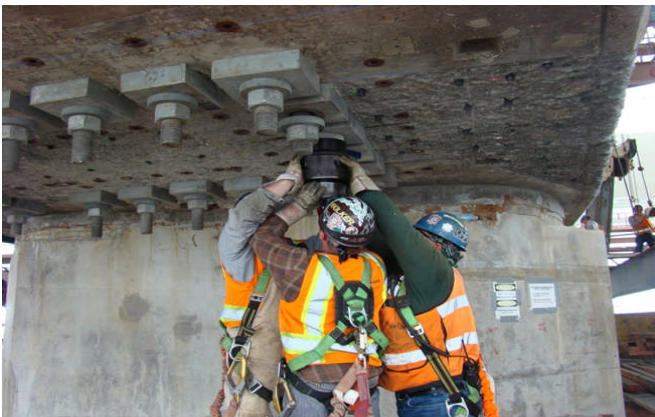
ABF ironworkers installing the three components of the Boltight jack on the bottom portion of the B4C1 anchor rod.

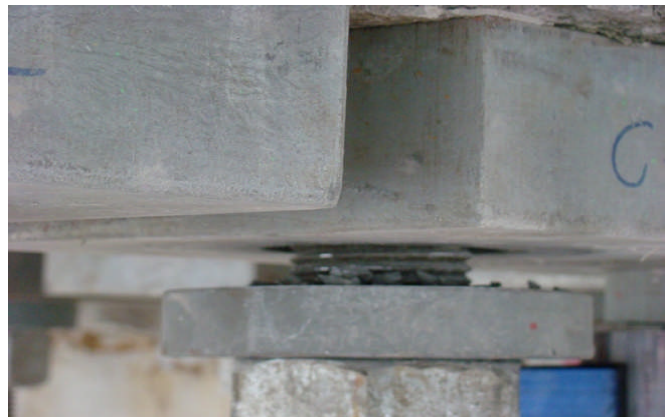
Grouting debris seen on the bottom washer after detensioning and raising the rod.

The ironworkers cleaned grouting debris from the washer and nut prior to being raised. It should be noted that ABF engineer Adam Reeve was present for the entire operation and continued to operate the top end jack.
